Manhole Inspection Summary

Manhole # S11GG2004MH

Location Address: **2204 ROGENE DR**

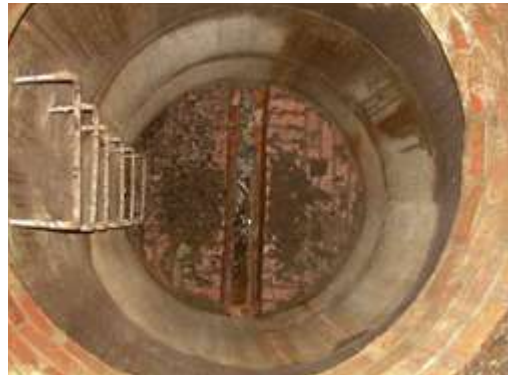
Top View

Adjustment, Corbel and Barrel infiltration.
Evidence of surcharge - Bench debris.
Channel debris.

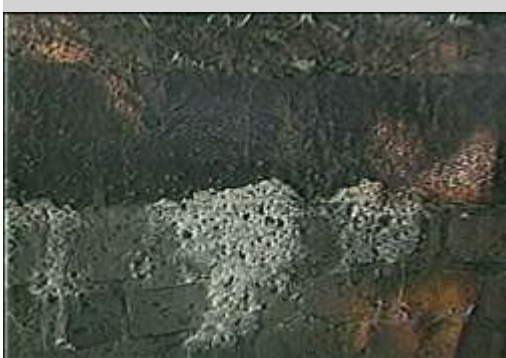
Defect

Frame leaks. Adjustment infiltration.

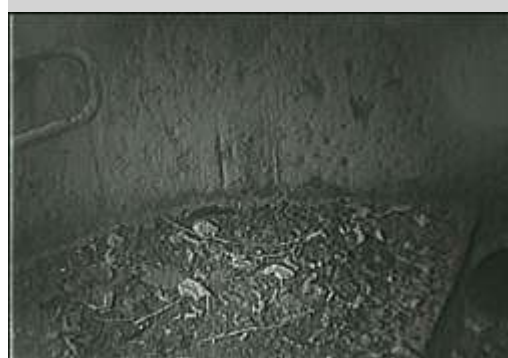
Defect

Bench debris.

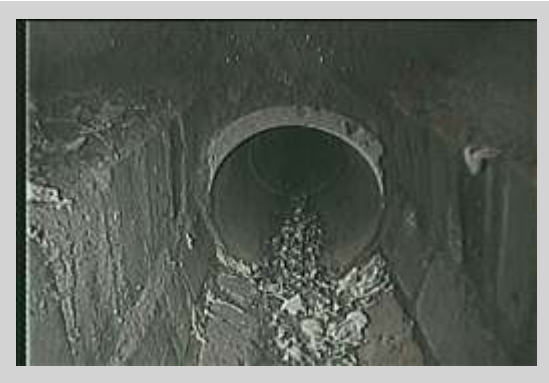
8 in. Circular Gravity Sewer Pipe Out @ 12 O'Clock

Deposits: ☐ None ☐ Mud ☐ Sludge ☒ **Debris** ☐ Grease

Silt Depth: **0** (in.) Deposits Extent: **Light**

Infiltration: **None** Pipe Seal Cond: **Cracked**

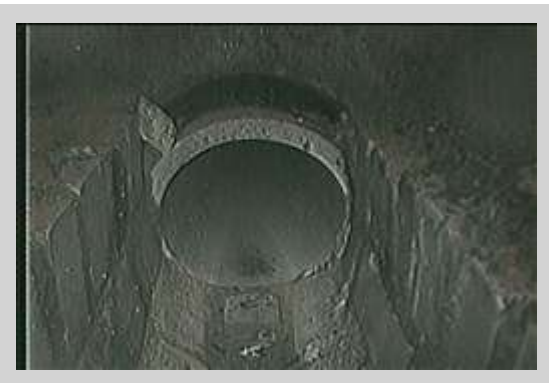
8 in. Circular Gravity Sewer Pipe In @ 6 O'Clock

Deposits: ☒ **None** ☐ Mud ☐ Sludge ☐ Debris ☐ Grease

Infiltration: **None** Pipe Seal Cond: **Unknown**
